ARR No. 5C19

WARTIME REPORT

A COMPARISON OF ANALYTICALLY AND EXPERIMENTALLY
DETERMINED ISOTHERMAL PRESSURE LOSSES IN A
HEAT-EXCHANGER INSTALLATION

By Wesley H. Hillendahl

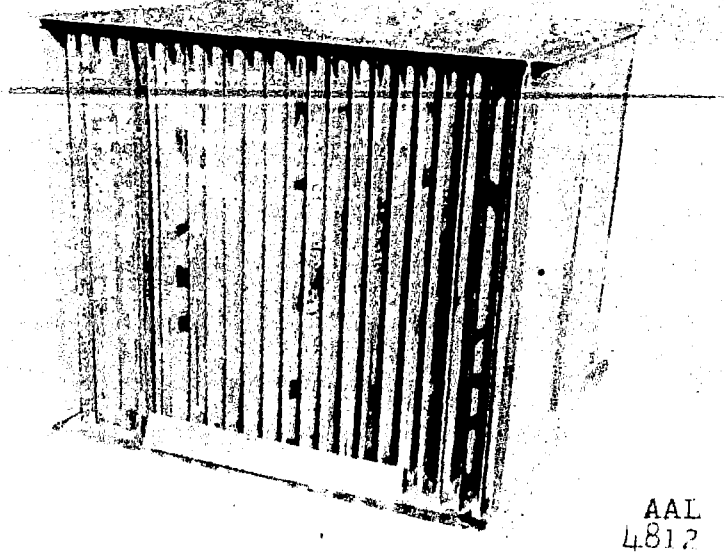
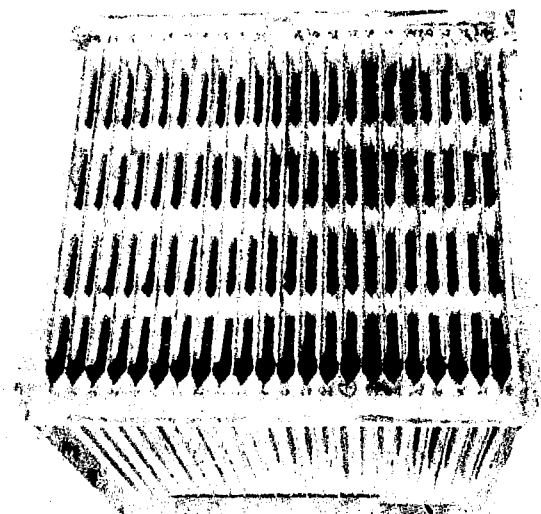
(a) Air passages

(b) Gas passages

Figure 1.- The exhaust-gas-to-air heat exchanger.

General views and construction details of the heat exchanger are shown in figures 1 and 2, respectively. In a cross-flow plate-type heat exchanger, such as the one tested, the exhaust-gas and air flow at right angles in alternate passages between formed steel plates, each plate thus forming an interface through which heat is transferred from the exhaust gas to the air. At design conditions of 155 miles per hour and 18,000 feet pressure altitude, a total of 800,000 Btu per hour is to be transferred from 12,000 pounds per hour of exhaust gas to an equal amount of air.

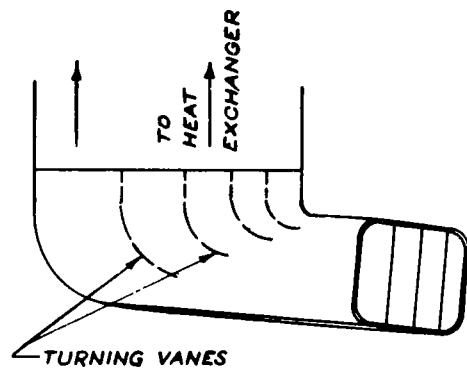
NOTE: ARROWS INDICATE DIRECTION
OF FLOW

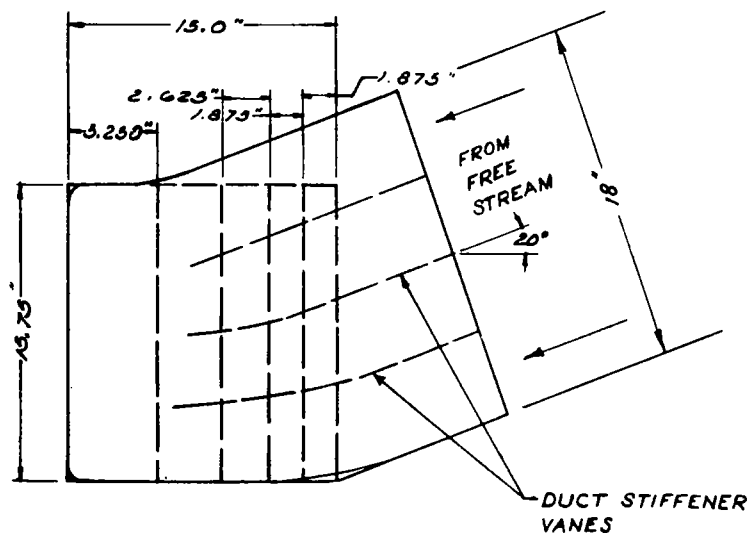
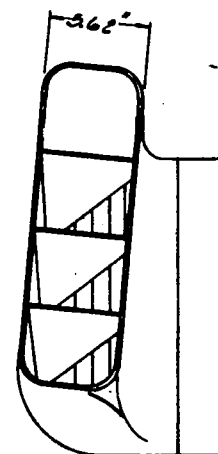
(a) INLET HEADER

FIGURE 3.- HEADERS WHICH DUCT AIR INTO
AND OUT OF THE HEAT EXCHANGER

The headers shown in figures 3 and 4 serve as transition pieces in ducting air and gas into and out of the heat

Inlet-header losses.— The air inlet header is shown in figure 3(a) to consist of a vaned elbow superimposed on a diffuser. The loss in the elbow was computed using data on vaned elbows published in reference 3 where the pressure-loss factor is plotted as a function of the s/c or gap/chord ratio in the vanes. This value ranged from 0.48 to 0.62, and the corresponding loss is approximately 25 percent of the velocity head at the header entrance. At the design flow rate of 12,000 pounds per hour, the velocity head is 0.90 inch of water and the turning loss is 0.225 inch of water.

The loss caused by the expansion in area was computed using data on straight diffusers which appear in reference 3. If the expansion is assumed to occur principally in the vanes, an effective angle of divergence, based on the length of the vanes (3 to 7 in.) and the ratio between the inlet and outlet areas ($A_2/A_1 = 2.3$), has a value between 11° and 23° . The corresponding loss factor is about 20 percent of the change in velocity head through the vanes, which at the design flow rate is 0.73 inch of water. The expansion loss is then 0.145 inch of water.

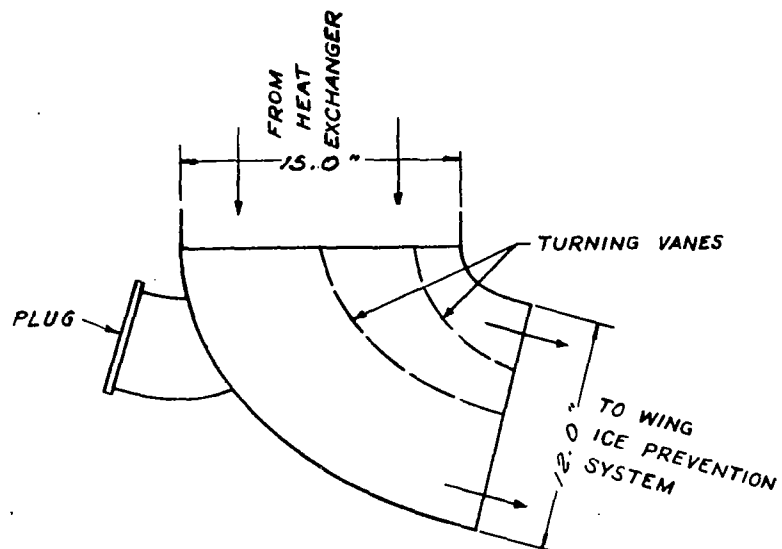
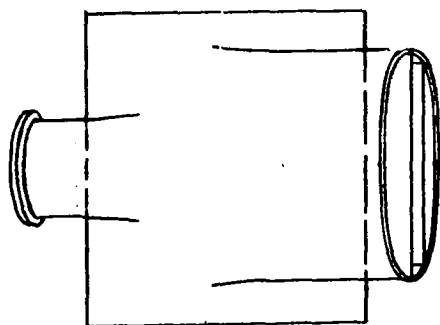
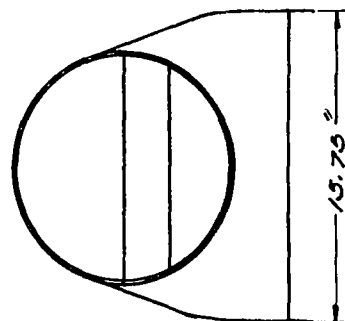
(b) OUTLET HEADER

FIGURE 3.- CONCLUDED

Outlet-header losses.- Since the contraction is gradual, the principal loss occurring in the outlet header was assumed to result from the elbow. Data in references 2 and 5 were used. For a value of s/c of about 0.3, the loss factor is 0.2. As a check, if the vanes are omitted, the loss corresponding to a mean-elbow radius/diameter ratio R/D of 1 has a value of 0.25. This is considered to be good agreement and the loss corresponding to a velocity head of 0.85 inch of water is about 0.17 inch of water.

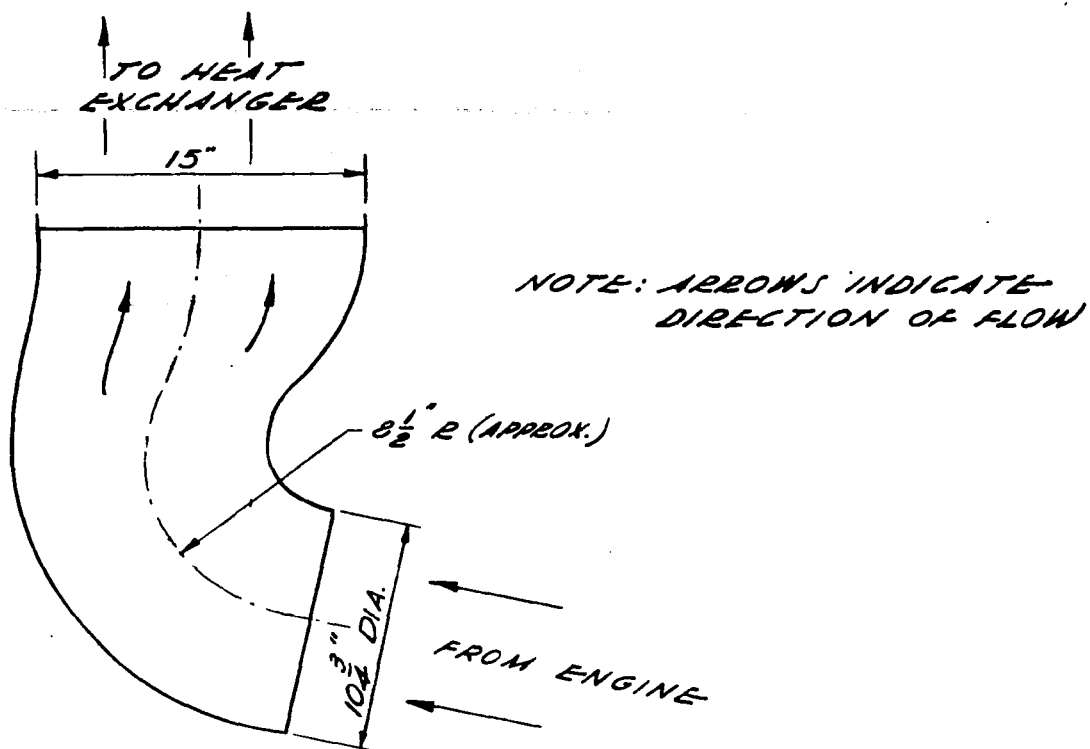
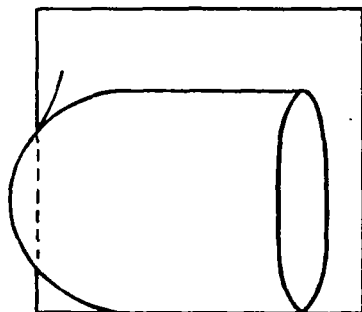
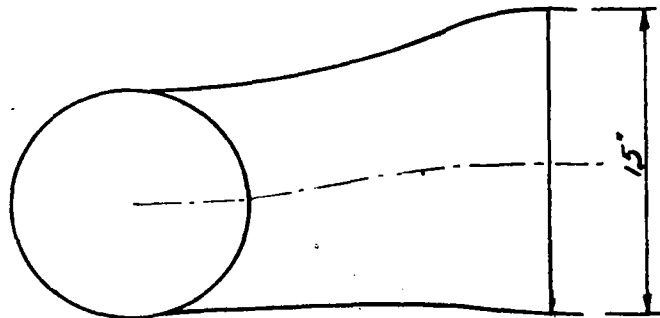
(2) INLET HEADER

FIGURE 4. - HEADERS WHICH DUCT EXHAUST
GAS INTO AND OUT OF THE
HEAT EXCHANGER

Inlet-header losses.- As the air (during isothermal tests) enters the inlet header (fig. 4(a)), it is immediately turned through approximately 90° in an elbow having a circular cross section. Following the turn it passes through an expansion in duct area. An elbow which is followed by a straight section of duct causes a lower pressure loss than one which is not, because of recovery in the duct. This effect is shown in reference 5 for rectangular ducts. The same reference presents data only on circular elbows which are followed by straight ducts; therefore, in order to apply

A header of the type shown in figure 4(a) is undesirable, not only because of the excessive pressure loss (in fig.

15 the pressure loss in the inlet header is shown to be larger than that in the heat exchanger), but also because of the uneven distribution of flow into the heat exchanger. Flow distribution in the various parts of the installation is shown in figures 16 to 19. It is to be noted that, while the heat exchanger has an appreciable damping effect on the distribution, figure 18 shows the uneven distribution caused by separation in the inlet header to persist into the region downstream of the heat exchanger.

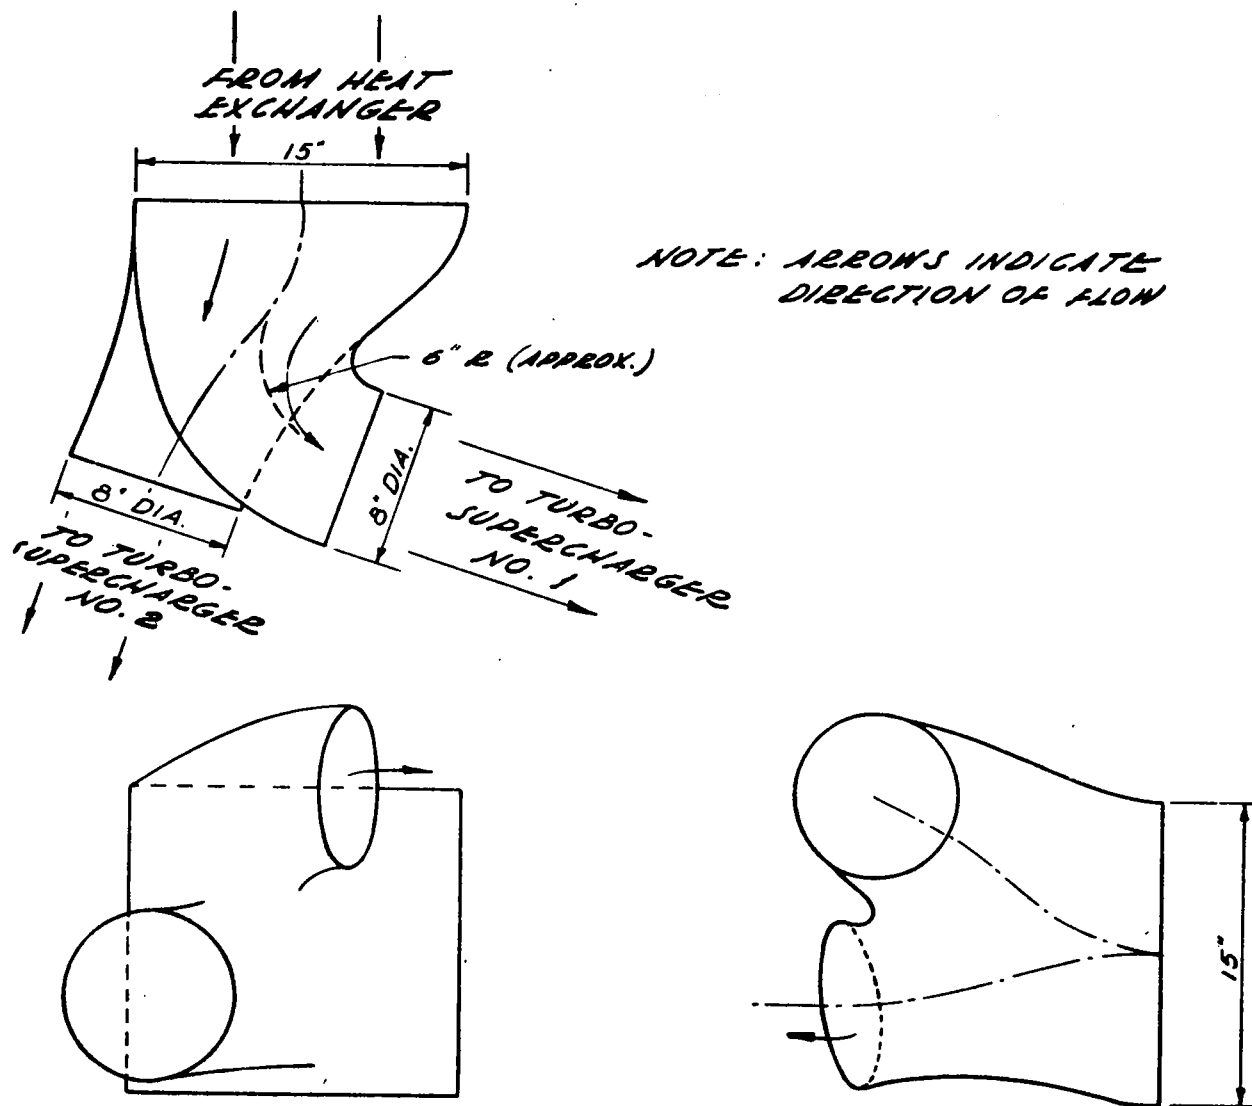
(b) OUTLET HEADER

FIGURE 4. - CONCLUDED.

Outlet-header losses.- As shown in figure 4(b), the gas outlet header consists of a combination wye and a contraction. This shape is too irregular to lend itself to elementary analysis. It will be noted, however, that a 90° turn occurs in

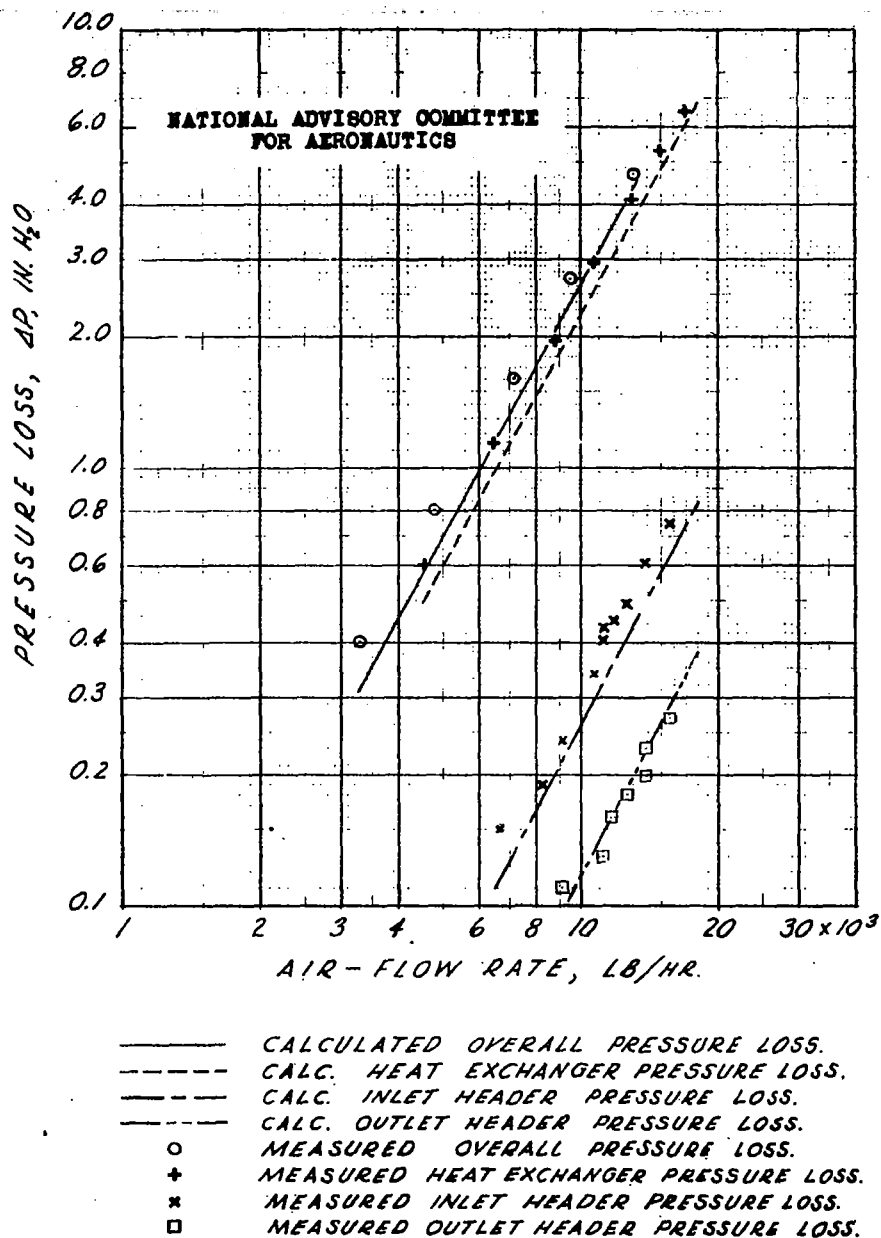
FIGURE 5.- CALCULATED AND MEASURED VALUES OF PRESSURE LOSSES IN THE AIR SIDE OF THE HEAT-EXCHANGER INSTALLATION AS A FUNCTION OF AIR-FLOW RATE.

The calculated values of pressure losses in the air-side ducting are plotted in figure 5.

The experimentally determined values of pressure losses in the air side of the installation are presented in figure 5 and those in the gas side in figures 6(a) and 6(b). The difference between the pressure losses determined with arrangements (c) and (d) in the test procedure was negligible and test points from both arrangements are presented in the curves in these figures.

A comparison of the analytical and experimental results in figures 5, 6(a), and 6(b) indicates that the predicted values of the losses were, in general, slightly low. The agreement being generally closer than 20 percent indicates that the analysis is applicable and is evidence of the fact that the interference effects did not cause a large increase in the losses in this installation over the predicted values in which the interference was assumed negligible.

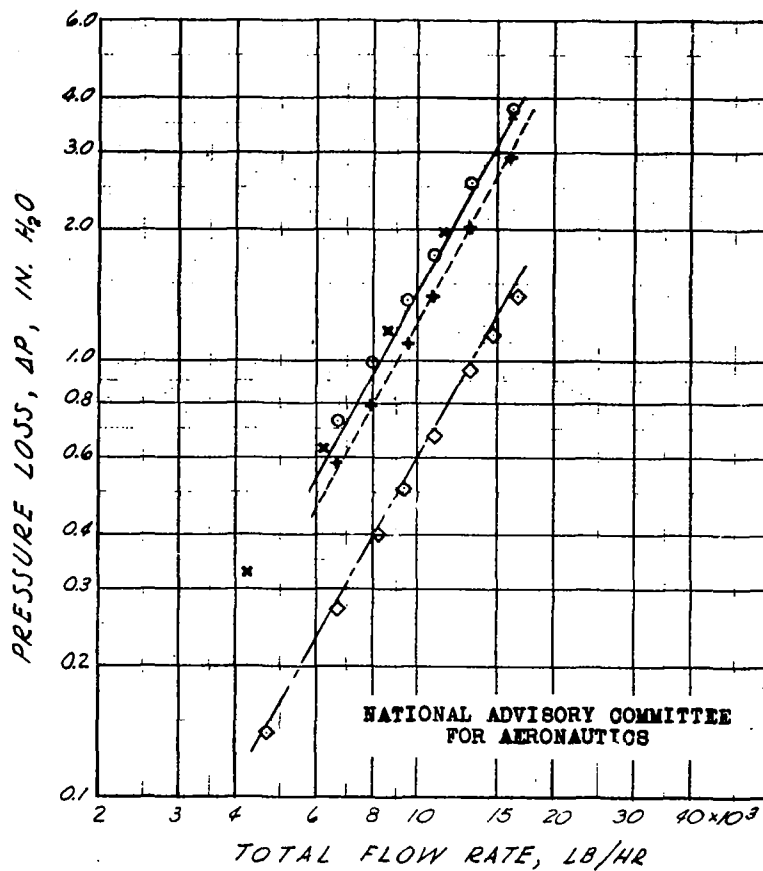
- CALCULATED OVERALL PRESSURE LOSS TO TURBOSUPERCHARGER No 1
 - - - CALCULATED OVERALL PRESSURE LOSS TO TURBOSUPERCHARGER No 2
 - · - · - CALCULATED HEAT EXCHANGER PRESSURE LOSS.
 - MEASURED OVERALL PRESSURE LOSS TO TURBOSUPERCHARGER No 1
 - + MEASURED OVERALL PRESSURE LOSS TO TURBOSUPERCHARGER No 2
 - ◇ MEASURED HEAT EXCHANGER PRESSURE LOSS.
 - * MEASURED OVERALL PRESSURE LOSS WITH TOTAL FLOW TO TURBOSUPERCHARGER No 2.
- (2) OVERALL AND HEAT-EXCHANGER LOSSES

FIGURE 6 — CALCULATED AND MEASURED VALUES OF PRESSURE LOSSES IN THE GAS SIDE OF THE HEAT-EXCHANGER INSTALLATION.

The calculated values of pressure losses in the gas-side ducting are plotted in figure 6.

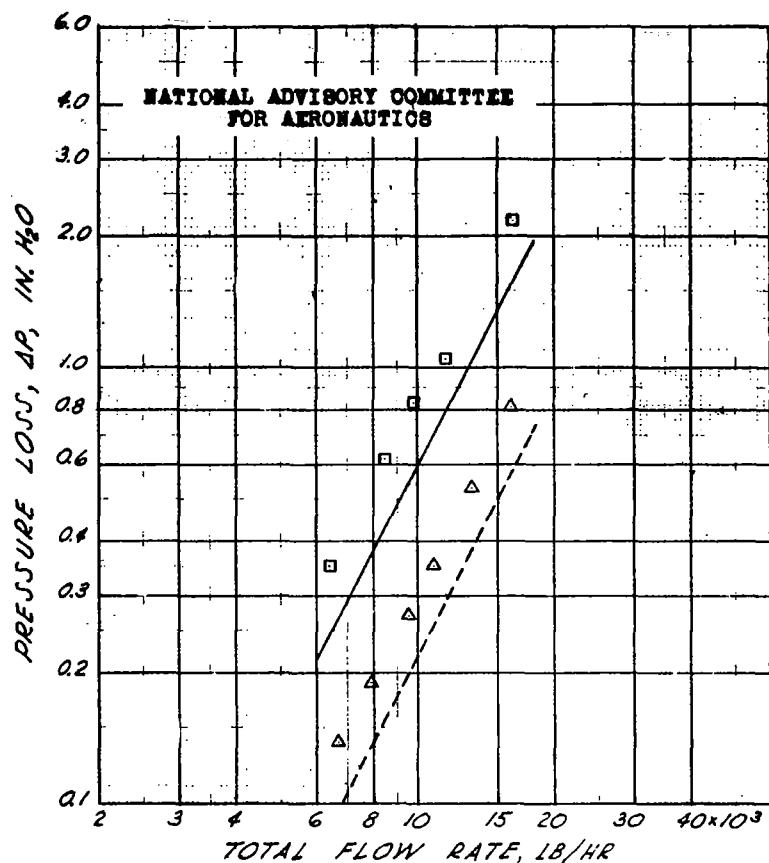
(6) HEADER LOSSES

- CALCULATED INLET HEADER PRESSURE LOSS.
 - - - CALCULATED ELBOW LOSS IN BRANCH OF OUTLET
 HEADER TO TURBOSUPERCHARGER NO. 1. FLOW RATE
 IN BRANCH EQUALS HALF OF TOTAL FLOW RATE.
 □ MEASURED INLET HEADER PRESSURE LOSS.
 △ MEASURED DIFFERENCE BETWEEN OVERALL PRESSURE
 LOSSES WITH FLOW EQUALLY DIVIDED BETWEEN
 TURBOSUPERCHARGERS.

FIGURE 6. — CONCLUDED.

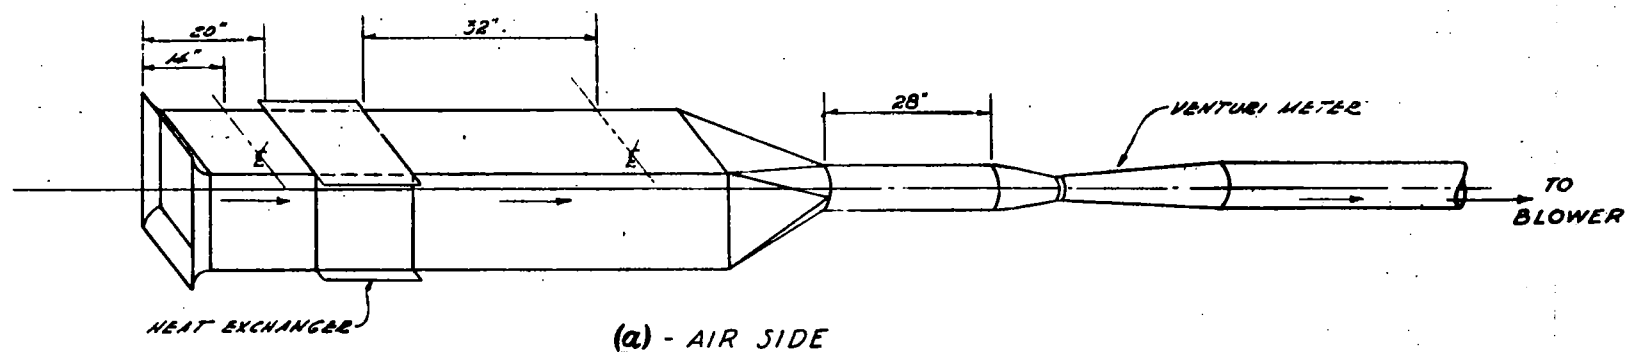
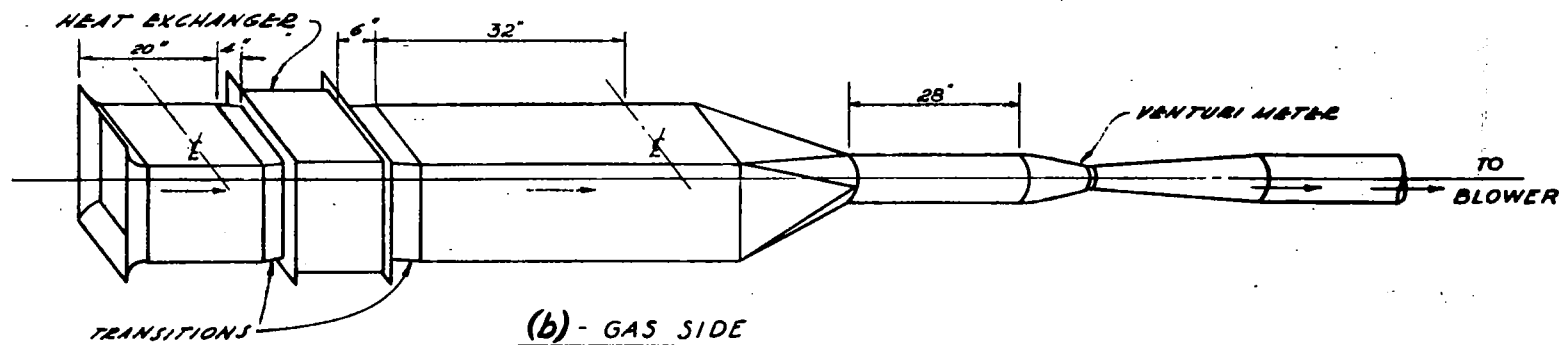
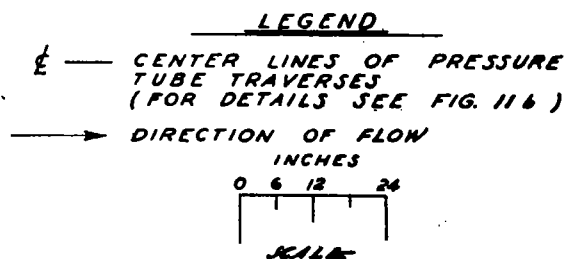
FIGURE 7. — LAYOUT OF DUCTING AND LOCATION OF PRESSURE
TUBES FOR MEASUREMENT OF PRESSURE LOSS
IN ISOLATED HEAT EXCHANGER

The heat exchanger and headers were assembled and tested for isothermal pressure losses in the arrangements shown in figures 7 to 10. As seen in these figures, a number of different arrangements were tested. It was possible in this manner to determine not only the pressure losses in the various parts, but also the magnitude of the interference effects.

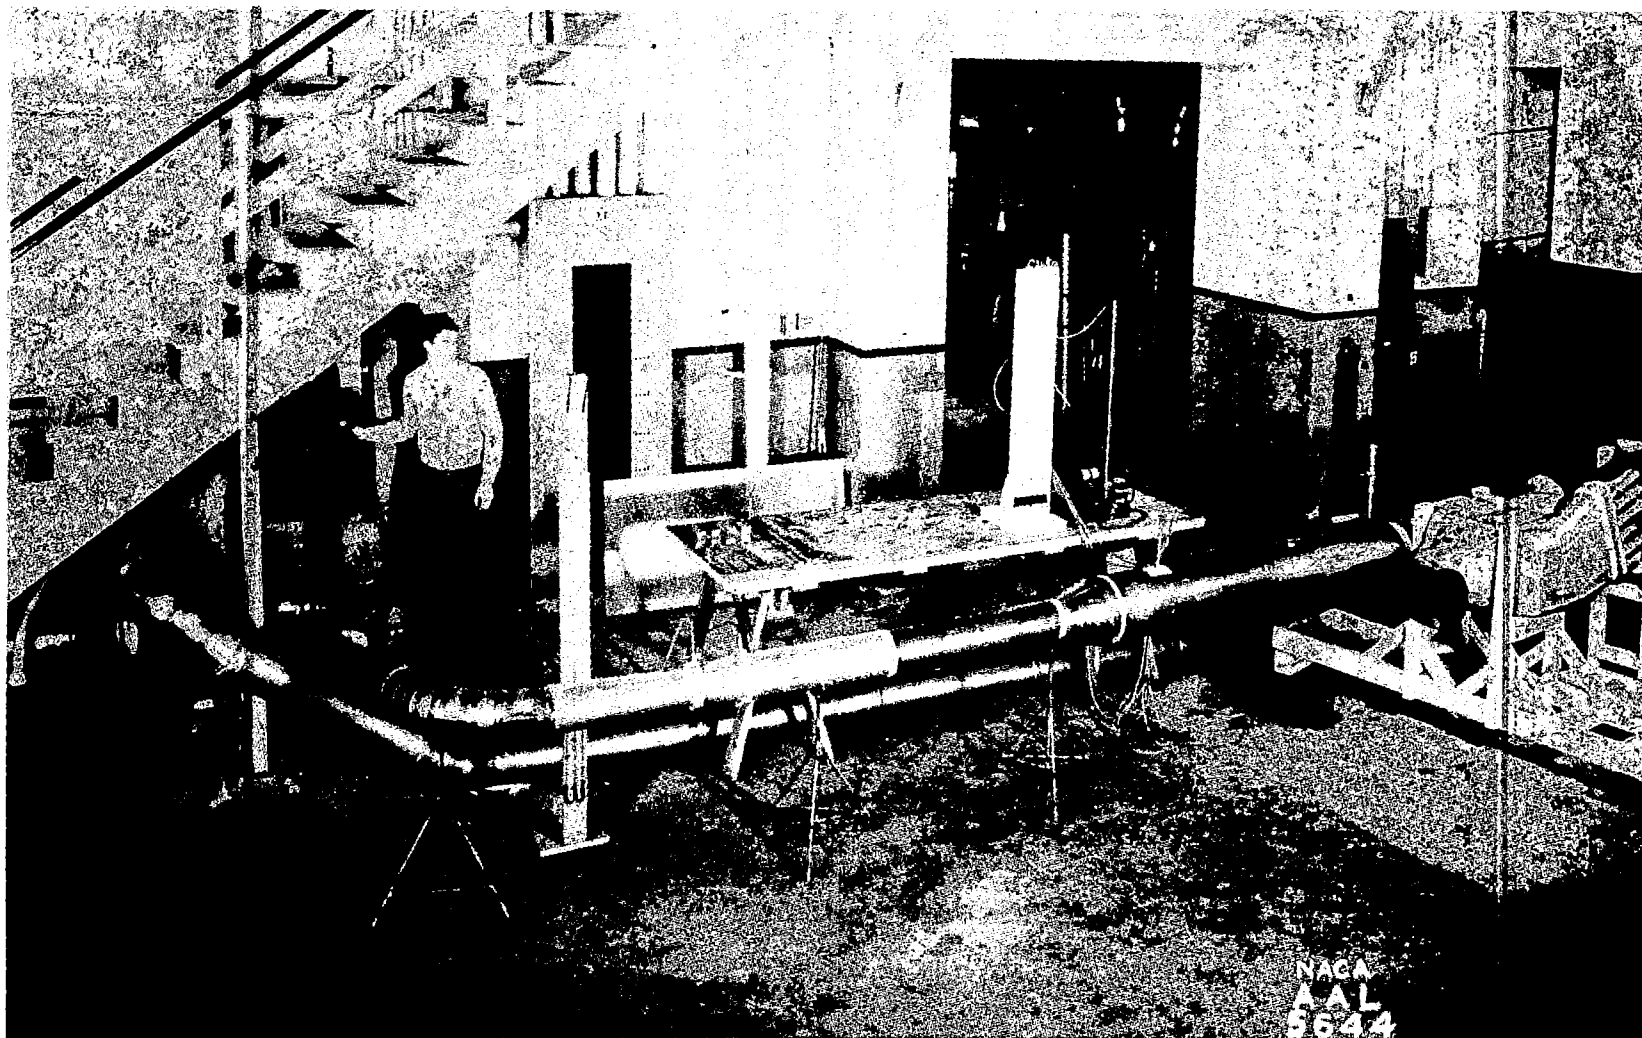
(a) Air side

Figure 8a,b.- Ducting and instrumentation for measuring the over-all pressure loss in the complete heat-exchanger installation.

- (a) The arrangements shown in figure 8 were used in obtaining the data on over-all pressure losses. It was in this form that the installation was originally designed.
- (b) The losses in the heat exchanger were determined with the arrangements shown in figure 7, the straight headers allowing measurement of the losses as unaffected by the headers.
- (c) Figures 9(a) and 10(a) show the arrangements in which the header losses were measured with the heat exchanger in place. These arrangements are identical with those in figures 8(a) and 8(b) except that traversing sections have been inserted between the headers and the heat exchanger.
- (d) Figures 9(b) and 10(b) show arrangements used in measuring header losses with the heat exchanger removed.

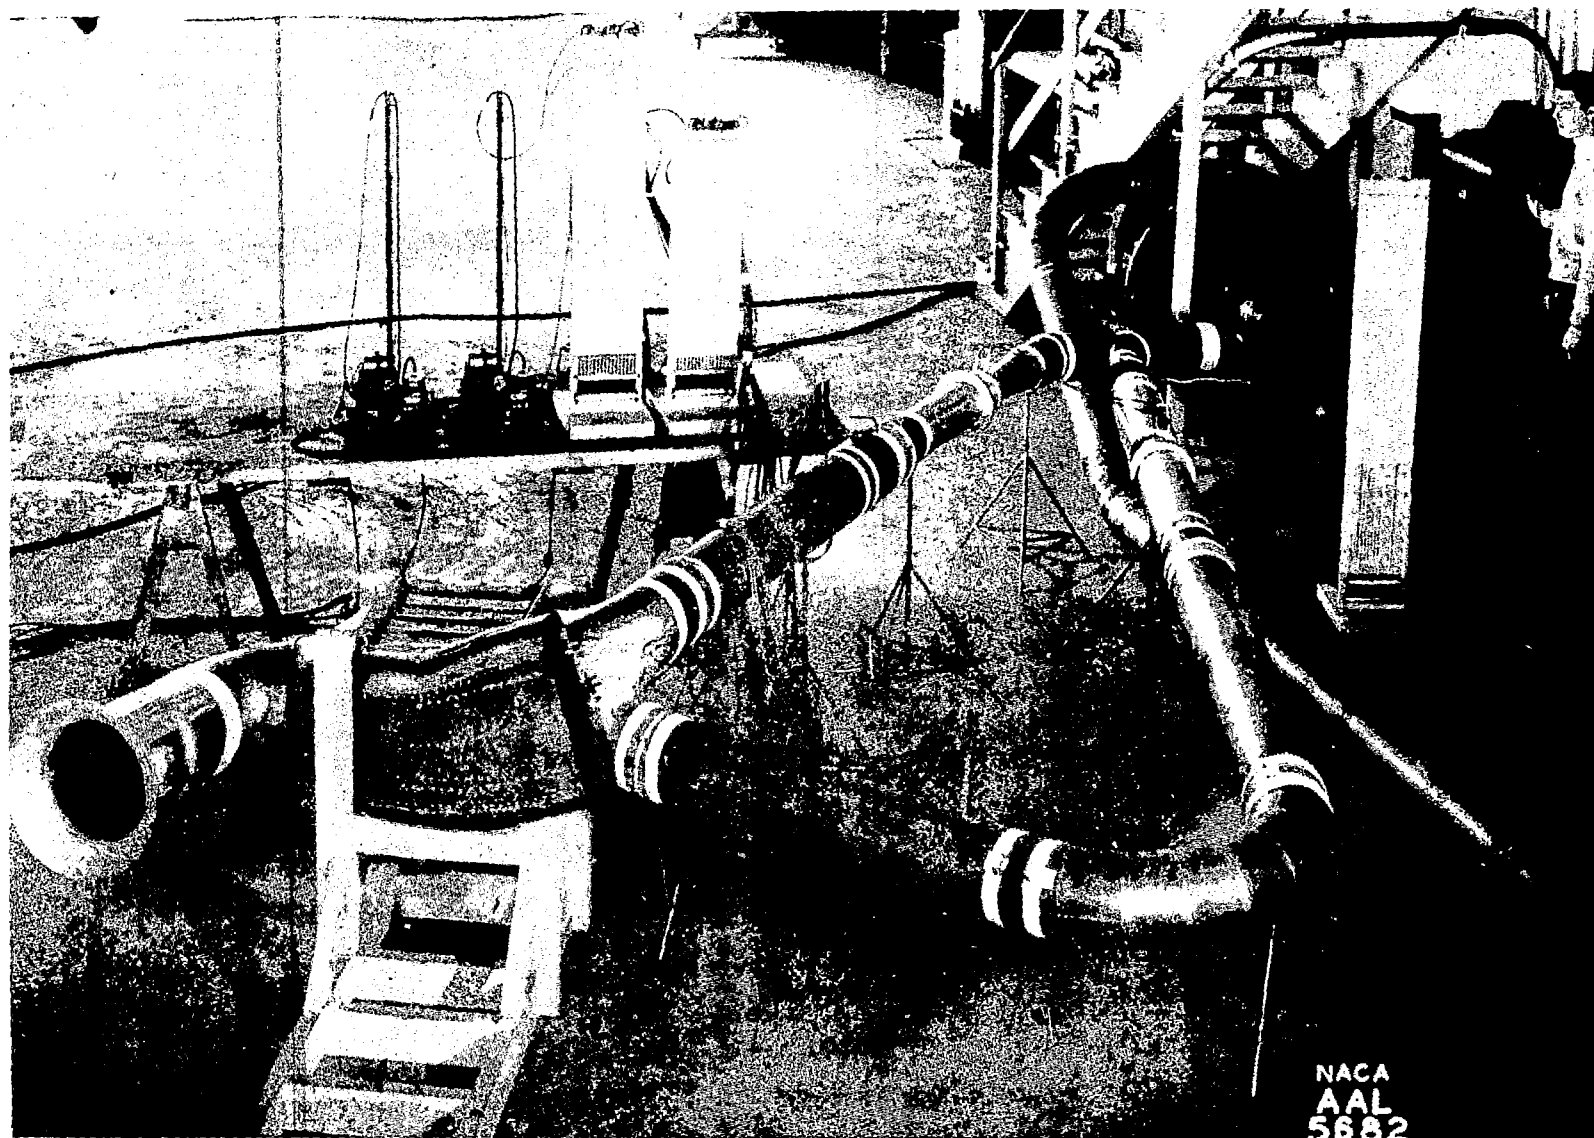
Fig. 8b

(b) Gas side

Figure 8.- (Concluded).

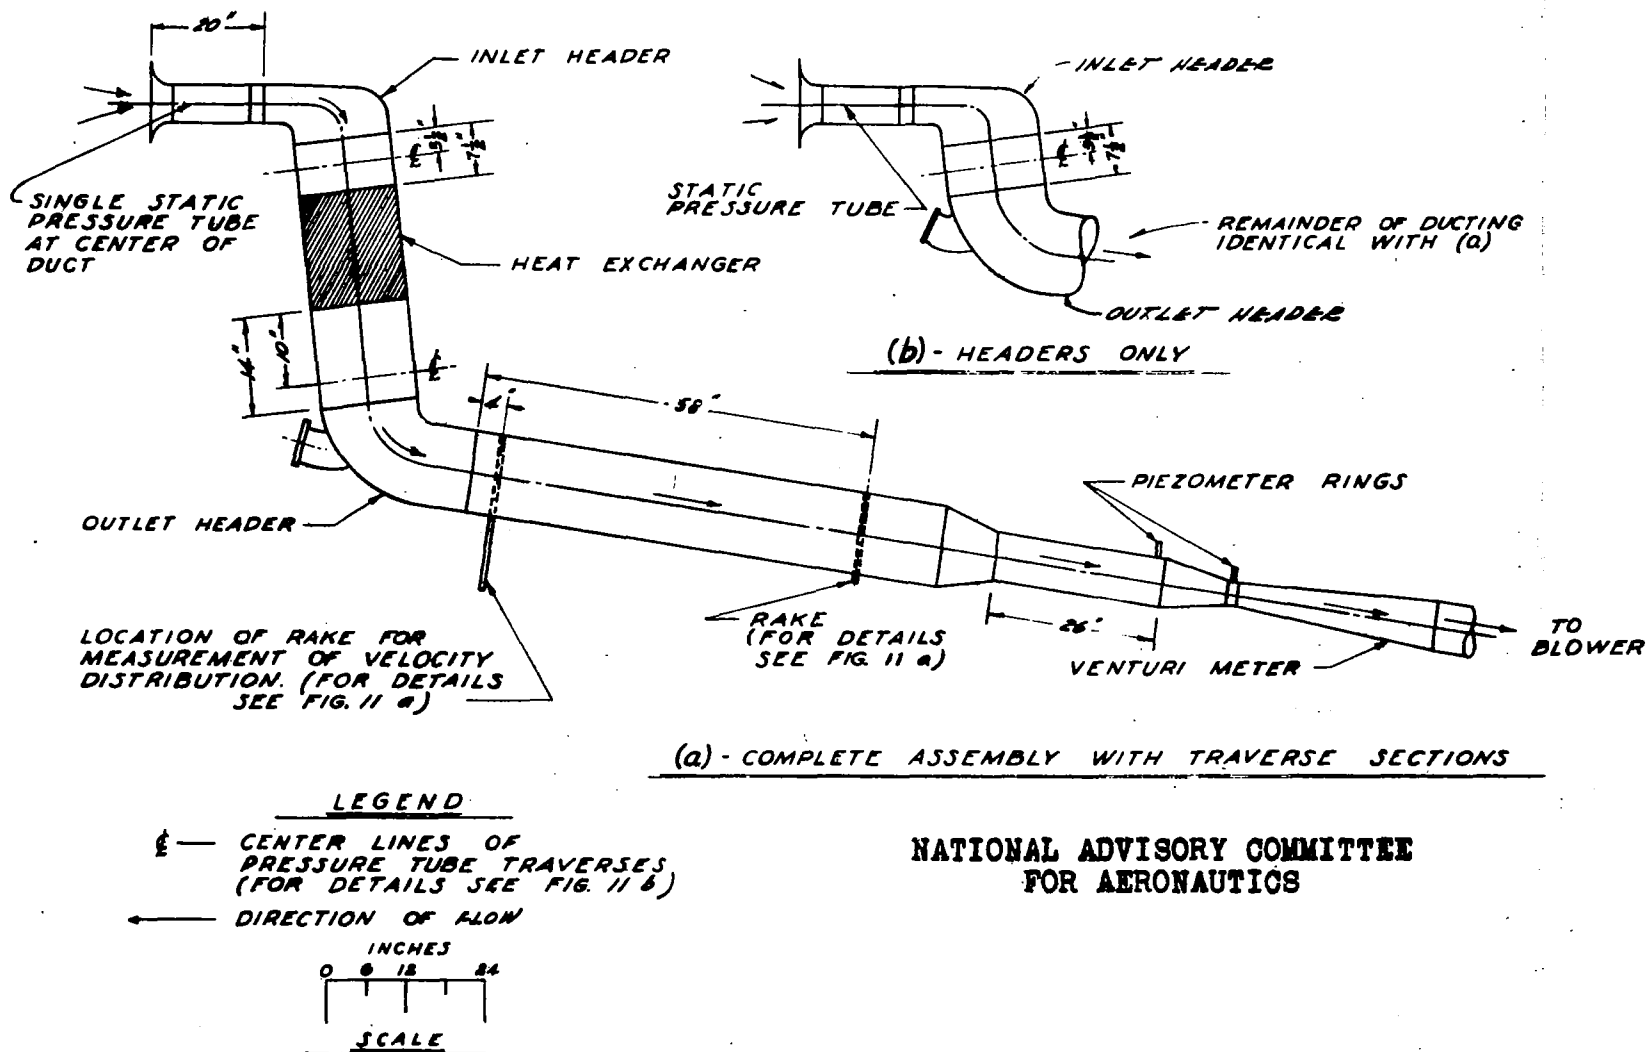
FIGURE 9. - LAYOUT OF THE DUCTING AND LOCATION OF THE INSTRUMENTATION FOR MEASURING THE PRESSURE LOSSES IN (a) THE PARTS OF THE AIR SIDE OF THE COMPLETE HEAT-EXCHANGER ASSEMBLY AND (b) THE AIR HEADERS.

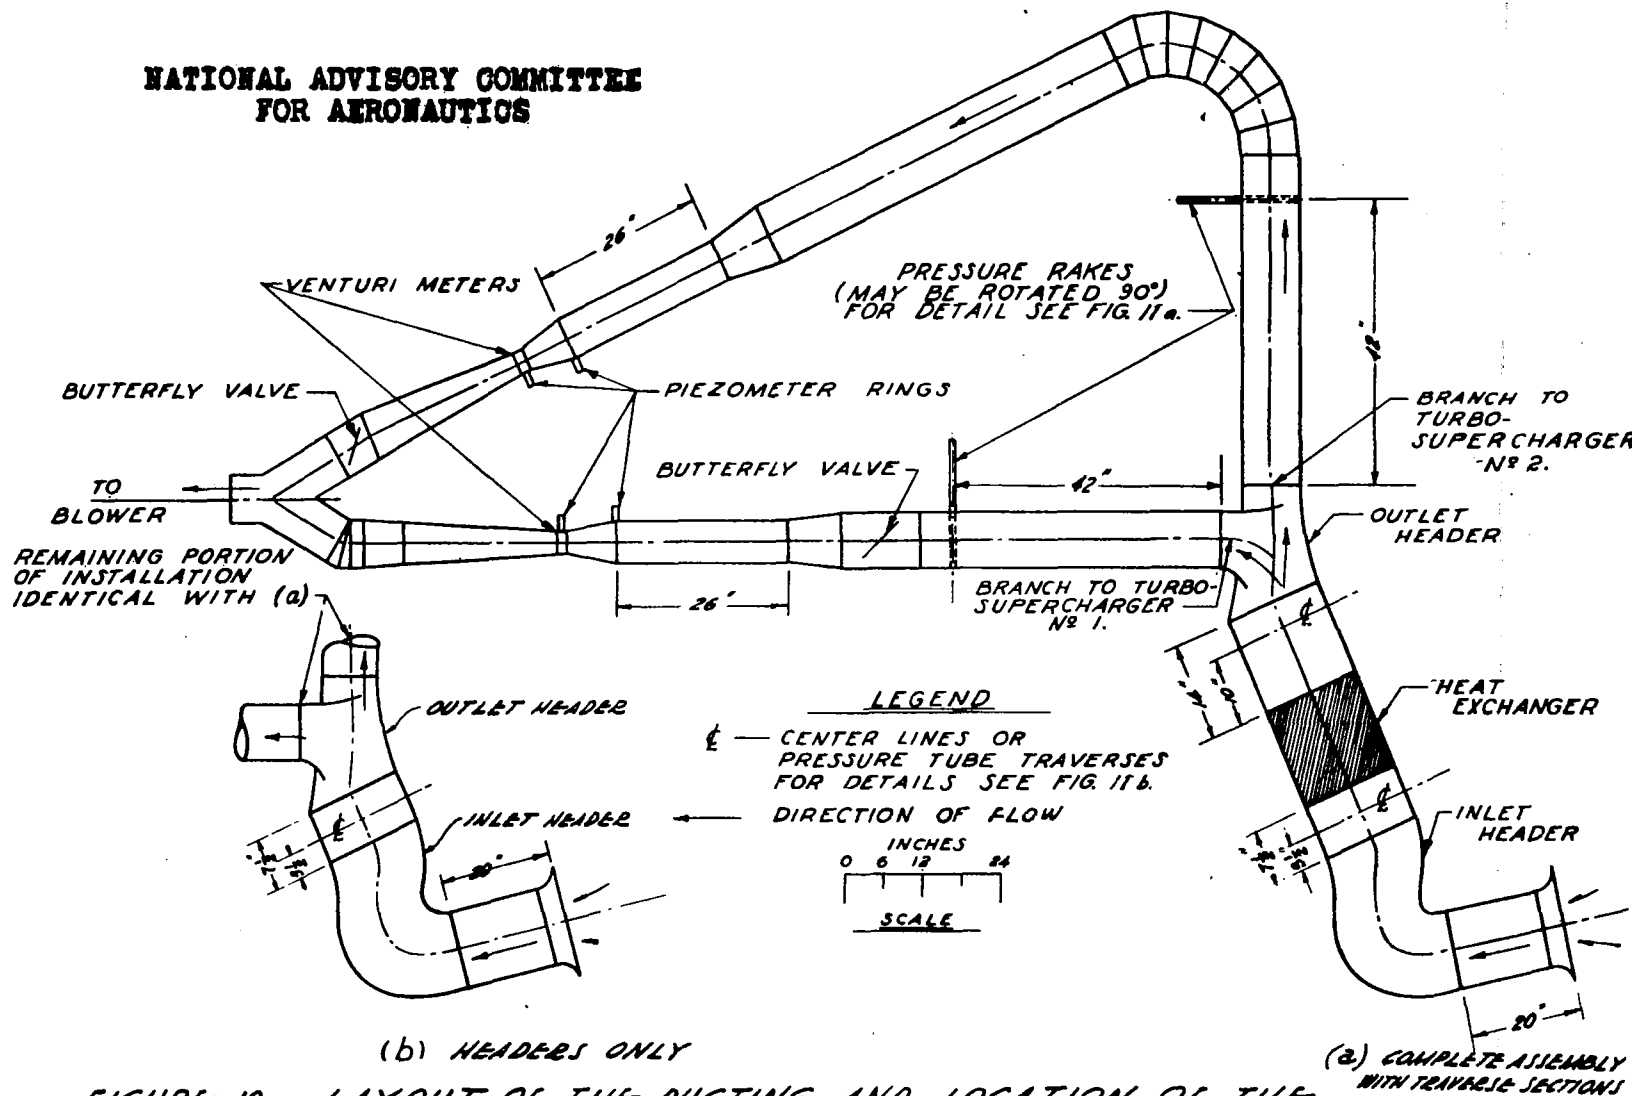
FIG. 10

FIGURE 10. - LAYOUT OF THE DUCTING AND LOCATION OF THE INSTRUMENTATION FOR MEASURING THE PRESSURE LOSSES IN (a) THE PARTS OF THE GAS SIDE OF THE COMPLETE HEAT-EXCHANGER ASSEMBLY AND (b) THE GAS HEADERS.

The butterfly valve upstream of the venturi meter in the duct to turbosupercharger 1 (fig. 10) was shown by the tests to have a negligible effect on the accuracy of the venturi under the conditions of the tests.

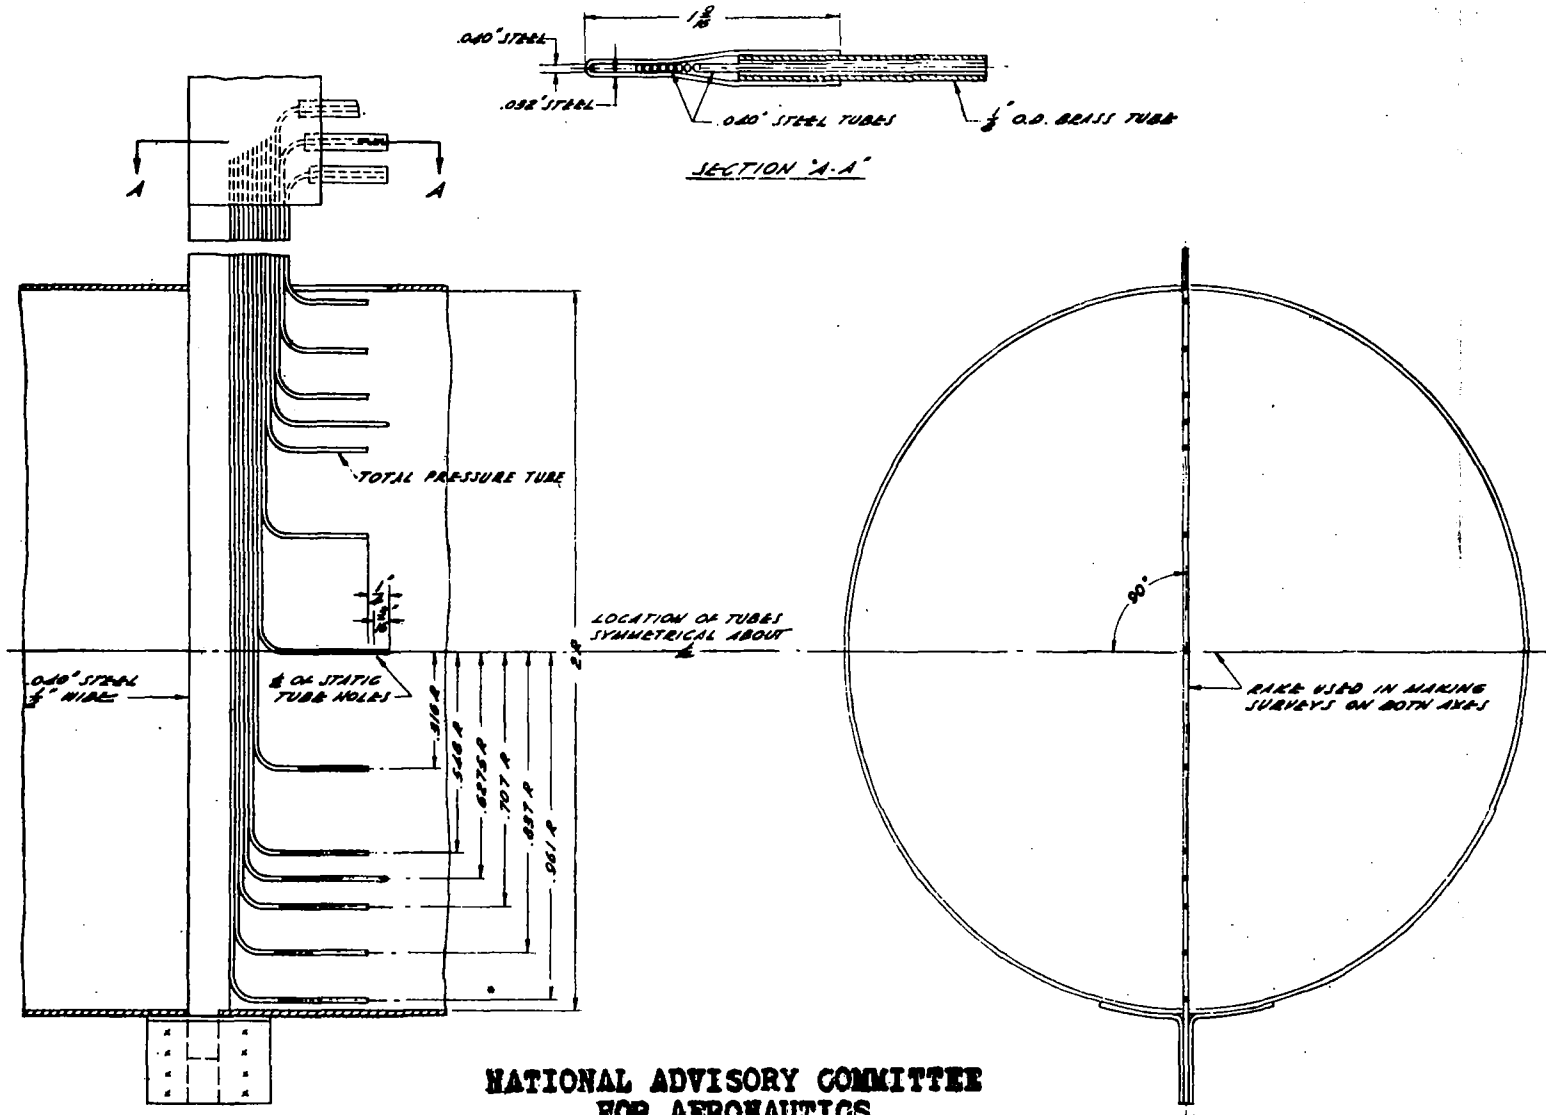
(3) PRESSURE RAKES

FIGURE 11. — INSTRUMENTATION DETAILS

The pressure rakes and traversing shielded total- and static-pressure tubes shown in figure 11 were used in making the pressure measurements. The manometers on which these pressures were indicated are shown in figure 8. In all cases, the multiple-tube manometers were used with the pressure rakes and micromanometers with the traversing tubes shown in figure

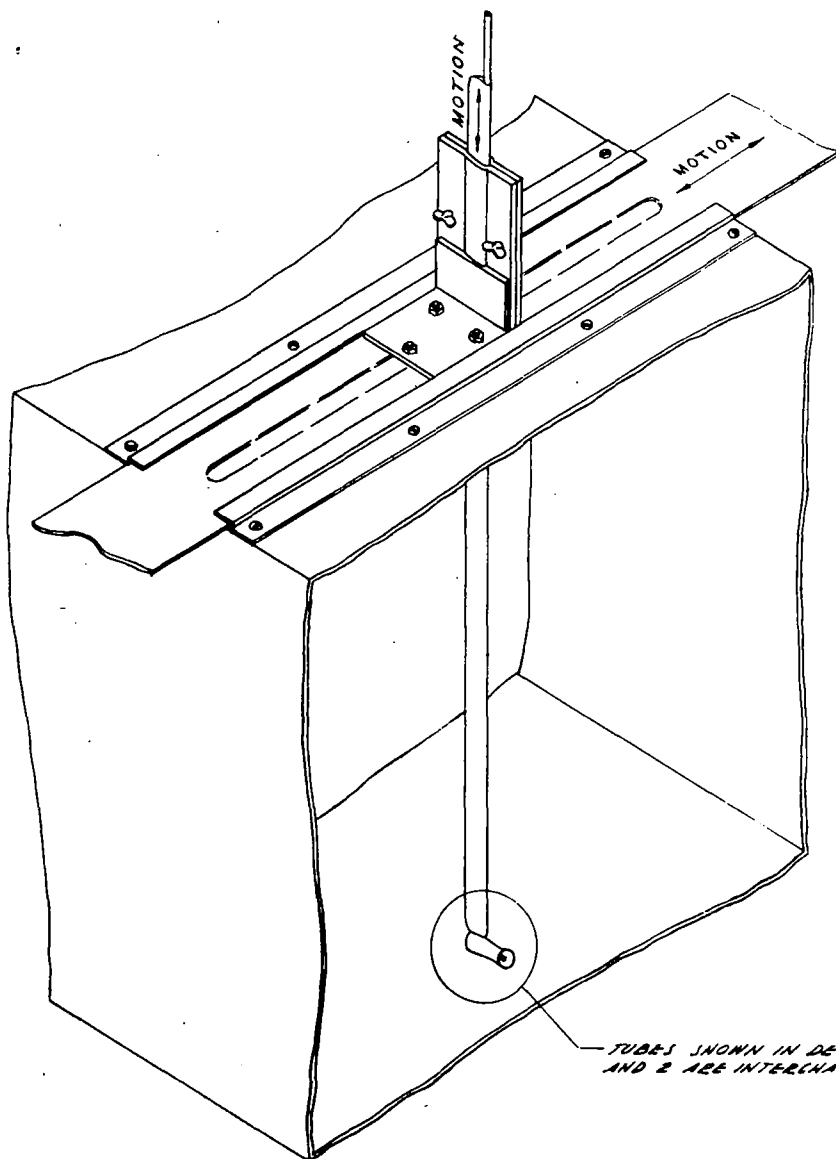
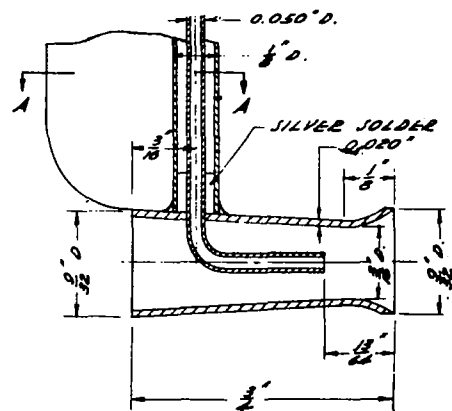
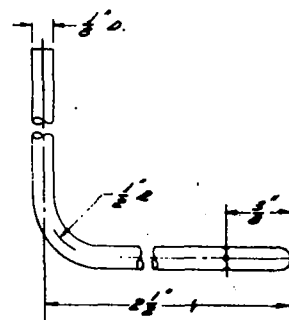
SECTION "A-A"

DETAIL 1
SHIELDED TOTAL PRESSURE TUBE

DETAIL 2
STATIC PRESSURE TUBE

(b) TRAVERSABLE SHIELDED TOTAL AND STATIC PRESSURE TUBES

11(b). These micromanometers are mechanically driven and are set up to indicate a single differential pressure to a least count of 1 millimeter of fluid (in this case, water). The use of multiple-tube manometers, together with the pressure rakes, made it possible to obtain instantaneous flow patterns on the entire diameter of the ducts. The shielded total pressure tubes were used in regions where the direction of flow was uncertain. These tubes will indicate the correct total pressure when yawed through angles up to 60° from the direction of flow.

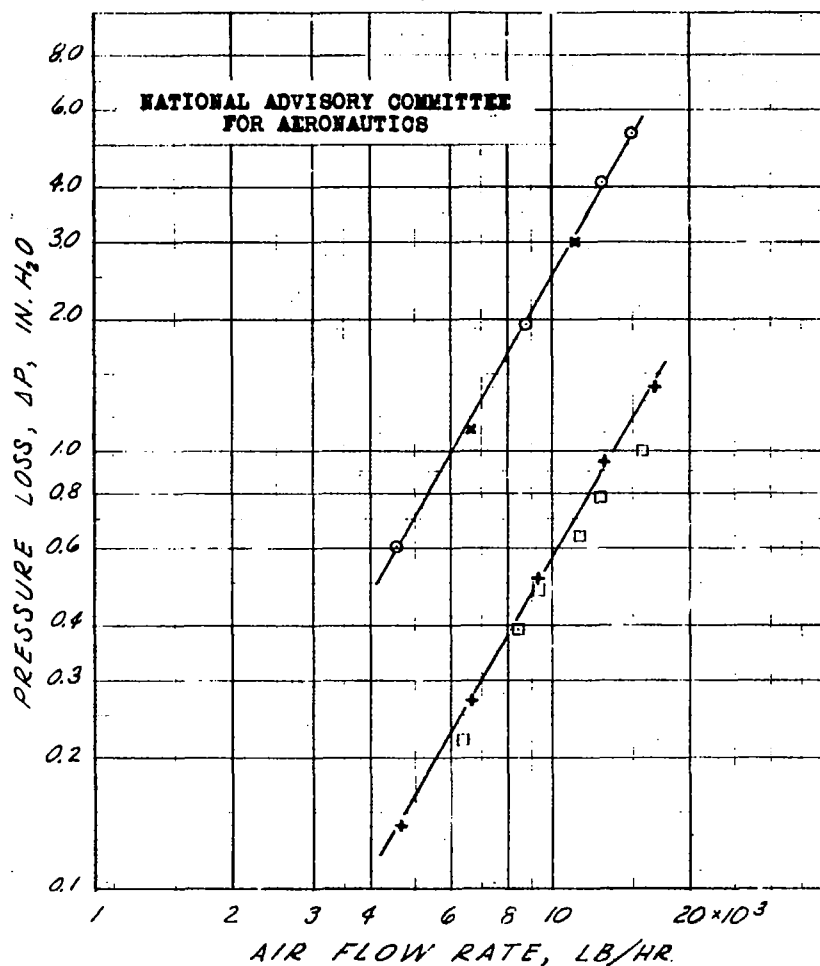
- MEASURED PRESSURE LOSS IN HEAT EXCHANGER WITH STRAIGHT HEADERS (SEE FIG. 7)
- AIR SIDE
 - + GAS SIDE
- MEASURED PRESSURE LOSS IN HEAT EXCHANGER WITH INSTALLATION HEADERS (SEE FIGS. 9a & 10a)
- x AIR SIDE
 - GAS SIDE

FIGURE 12.- COMPARISON OF MEASURED VALUES OF PRESSURE LOSS IN THE HEAT EXCHANGER WITH AND WITHOUT HEADERS AS A FUNCTION OF FLOW RATE.

In order to show the effect of the headers on the pressure loss in the air and gas passages of the heat exchanger, additional data were taken using the arrangements shown in figures 9(a) and 10(a). These data are compared in figure 12 with those taken using the arrangement in figures 7(a) and 7(b). Likewise, to show the effect of the traversing sections (which were installed between the headers and heat exchanger to measure the header losses) on the over-all pressure loss, data taken from the arrangements shown in figures 8(a), 8(b), 9(a), and 10(a) are plotted in figure 13.

The difficulty in obtaining accurate measurements in the region between the headers and heat exchanger is further emphasized by the comparison of gas-side data for the two conditions shown in figure 12 where the installation headers appear to reduce the pressure loss in the gas side of the heat exchanger. Such an effect is improbable and this difference is attributed to inaccuracies in measurement.
